**भारत सरकार / GOVERNMENT OF INDIA**  
**पत्तन, पोत परिवहन और जलमार्ग मंत्रालय**  
**MINISTRY OF PORTS, SHIPPING AND WATERWAYS**  
**समुद्रीय प्रशासन महानिदेशालय, मुंबई**  
**DIRECTORATE GENERAL OF MARITIME ADMINISTRATION, MUMBAI**

**DGMA Circular No. 60 of 2026**  
**Nautical Wing – Casualty Investigation Branch Circular No. 01 of 2026**

**Subject: Accident Release of Free-fall Lifeboat (FFLB) at sea**

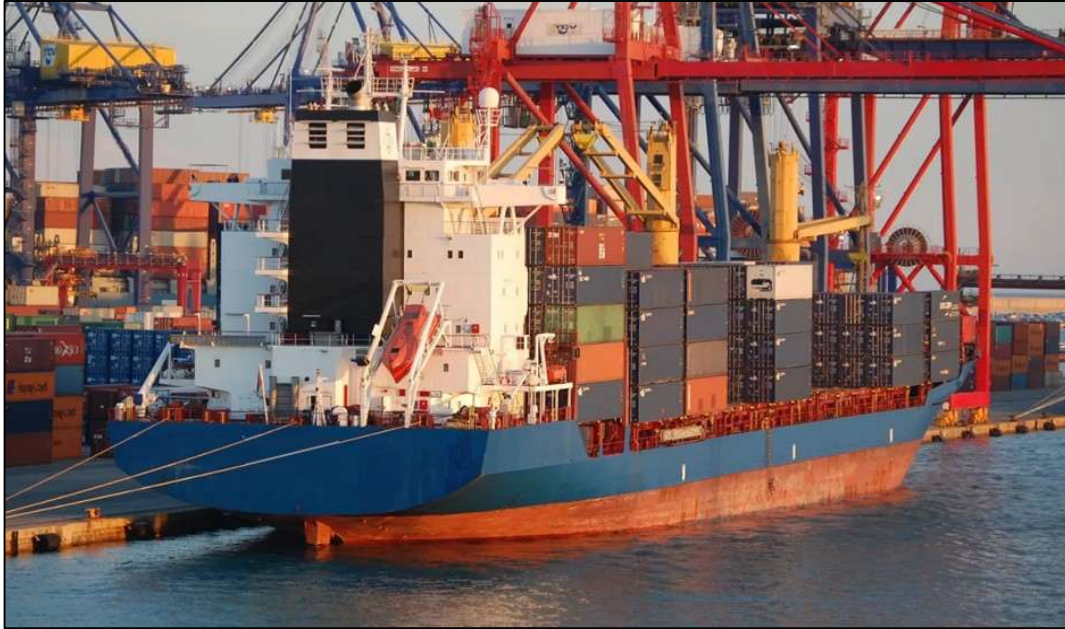
**Figure 1:** General view of the vessel involved in the incident and Free fall lifeboat arrangement

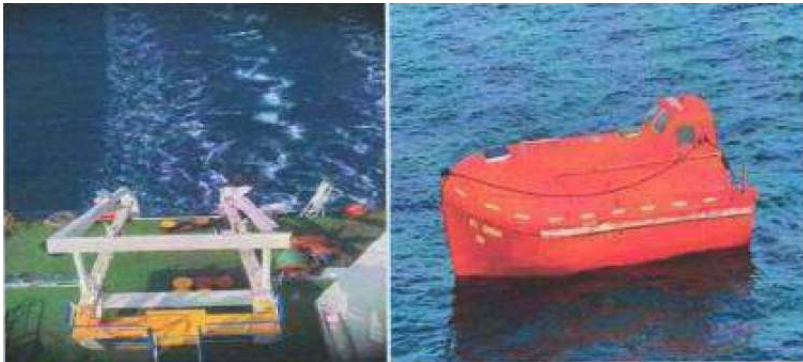
The vessel turned around and the lifeboat was sighted in the water at 1430 hrs. It was recovered safely at 1653 hrs, and the vessel resumed passage at 1700 hrs after cancelling the security message and updating all concerned. No casualties, pollution or structural damage were reported.

**Figure 2:** *Stowage position of the FFLB. Left: the empty cradle after the release. Right: the FFLB as sighted in the water.*

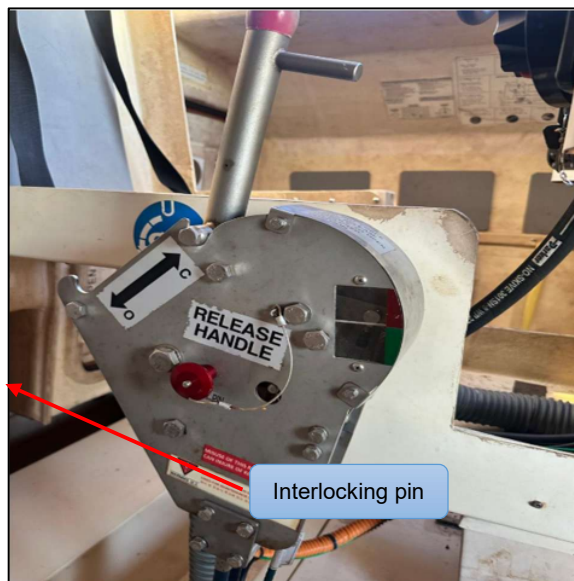
- (i) The primary cause was age-related deterioration of the release hook. The FFLB's release hook was found to be considerably thinner and corroded. A post-incident inspection report issued by the service station also confirms the same.
- (ii) This thinning resulted in loss of proper engagement between the hook and the holding cam, allowing the hook to slip free even while the cam remained in the locked position. Under normal operating conditions, release of the hook requires deliberate manual activation of the release mechanism by removing the interlocking pin.

**Figure 3:** *Release Handle and interlocking pin arrangement*

- (i) The FFLB was released due to a mechanical failure of the locking mechanism, rather than operational error.
- (ii) The release hook had corroded considerably and weakened as a result of ageing. Its surface area and structural integrity were so diminished that the holding cam was unable to retain it. The hook disengaged due to vessel vibration acting on the weakened contact surfaces.

- (i) Inspect the release hook and associated holding cam assembly, and repair or renew as necessary, in consultation with the lifeboat manufacturer and the classification society.

- (ii) Establish the service life of the hook and its cam in accordance with the manufacturer's instruction manual. Replace the hook mandatorily at the end of its specified service life, and include this requirement in the vessel's Planned Maintenance System (PMS).

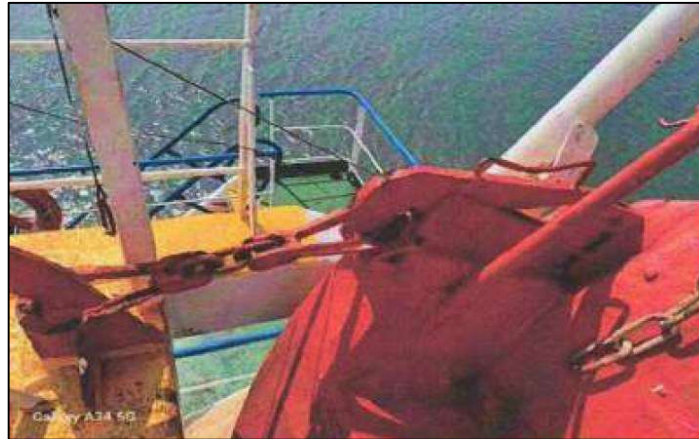
- (iii) The bypass valve of the hydraulic unit was kept in the open position.<sup>1</sup> To activate the releasing piston, this bypass valve must also be closed.

**Figure 4:** *The FFLB in its stowed position on the launching arrangement, showing the securing arrangement.*

- (viii) Where a free-fall lifeboat has additional sea lashings or securing arrangements specified by the manufacturer:
- Check that the lashings are in good condition and that the quick-release/slip arrangement operates freely.
  - Avoid additional sea lashings unless they have a manufacturer/Class/Flag-approved quick-release system.
  - Ensure the lifeboat can be launched by two crew members within 5 minutes and is ready for immediate use.
  - Display clear release instructions at the point where such lashings are released.
  - Assign responsibility for removing the sea lashings in the muster list.
  - If sheathed wire lashings are fitted, inspect them regularly through the PMS for signs of water ingress and corrosion.
